BELZONA REPAIRED STEPS IN GREAT CONDITION AFTER 5 YEARS (2)

Industry: Buildings & Structures
Application: FPA-Floor Problem Areas
Substrate: Concrete
Products: * Belzona® 4131 (Magma Screed) ,

Customer Location: Local City Council - N.East England
Application Date: May 2005

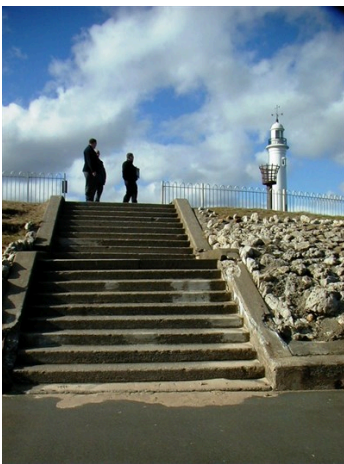
Due to the promenade steps being on the sea front, over a number of years they had deteriorated where the nosings were damaged and in dangerous condition.

- * Steps before repair in May 2005 ,
- * Steps immediately after repair in May 2005 ,
- * Steps five years on in May 2010 ,
- * Further view of steps after five years service. ,

Application was carried out in accordance with Belzona Know-How System Leaflet FPA-1.

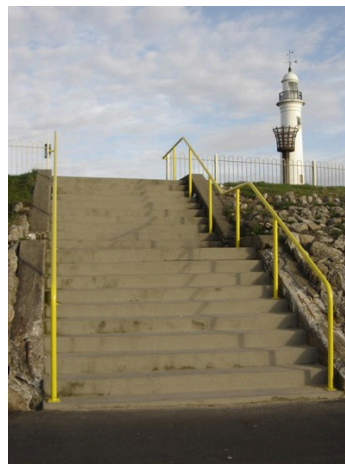
not effective due to poor adhesion and the nature of the coastal environment. An inspection of the Belzona application was carried out after 5 years and there is no signs of deterioration or damage to nosings whatsoever.
