# BELZONA REPAIRED STEPS IN GREAT CONDITION AFTER 5 YEARS (2)

Industry: Buildings & Structures  
Application: FPA-Floor Problem Areas  
Substrate: Concrete  
Products: \* Belzona® 4131 (Magma Screed) ,

Customer Location: Local City Council - N.East England  
Application Date: May 2005

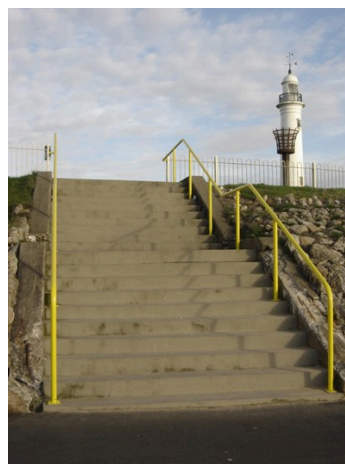
- \* Steps before repair in May 2005 ,
- \* Steps immediately after repair in May 2005 ,
- \* Steps five years on in May 2010 ,
- \* Further view of steps after five years service. ,

not effective due to poor adhesion and the nature of the coastal environment. An inspection of the Belzona application was carried out after 5 years and there is no signs of deterioration or damage to nosings whatsoever.
