BELZONA REPAIR AND PROTECTION OF REFRIGERANT COMPRESSOR

ID: 146

Intercooler unit on a tugboat

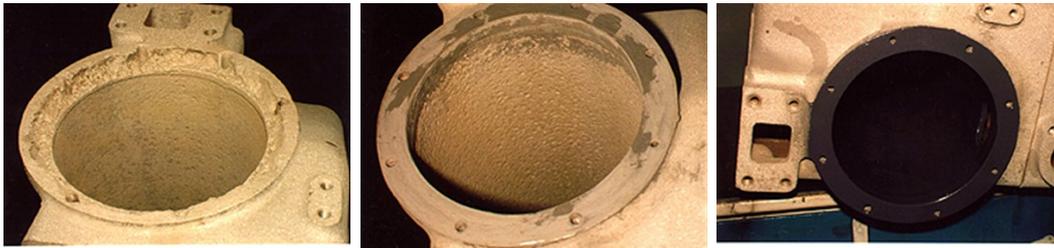
Photograph Descriptions

Severe erosion-corrosion particularly around flange faces, mainly by bimetallic corrosion.

- * The degree of metal wastage clearly evident ,
- * Profiles rebuilt with Belzona® 1111 ,
- * Complete protection provided by Belzona® 1321 coating ,

Application was carried out in accordance with Belzona System Leaflets FBC-2 and FBC-5.

Units fully restored and protected without resorting to welding.
