BELZONA SIMPLIFIES REPAIRS IN GLASS LINED REACTORS

Customer Location: *Chemical Fertilizer Plant in the Middle East*

Application: *TCC-Tanks and Chemical Containment Areas*

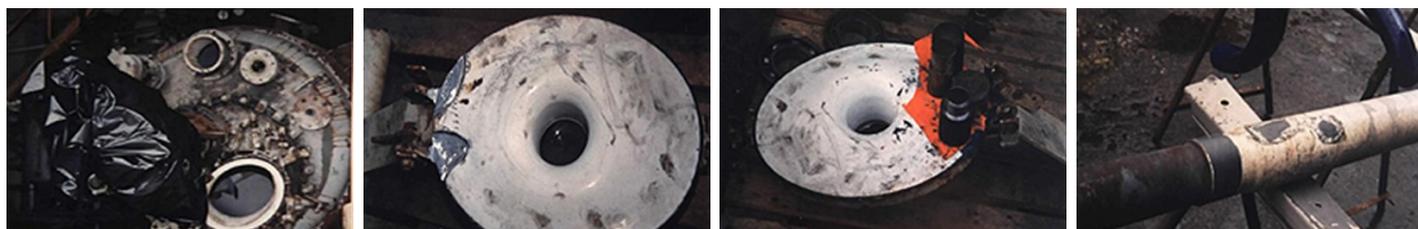
Photograph Descriptions

Damage to the glass lining caused by mis-handling of the covers and introduction of foreign bodies into the mixing process.

- * General view of the reactor ,
- * Typical damage to glass lining on cover ,
- * Repairs to cover being made. Note use of mixing board to form smooth surface on Belzona® 1311 ,
- * Local repairs with Belzona® 1311 to damaged glass protection on mixer shaft ,

The Belzona repair can be completed in three hours. Making and securing Tantalum patches can take several days. Belzona® 1311 is only viable repair on agitator, Tantalum patches cannot be secured.
