# PROTECCIÓN INTERNA Y EXTERNA EN BOMBA SUMERGIBLE

ID: 1475

Ubicación del cliente: *UNILEVER / Guayaquil - Ecuador*  
Fecha de aplicación: *Junio 2010*

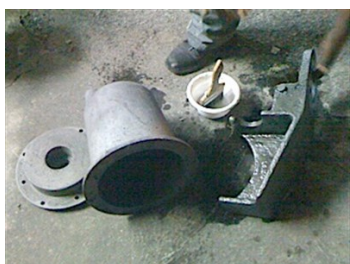
- \* Vista del equipo ya granallado ,
- \* Limpieza con Belzona® 9111NF ,
- \* Belzona® 6111 para proteger la carcasa exteriormente ,
- \* Aplicación de Belzona® 1321 ,
- \* ,
