RESEATING NEW RUDDER BEARING WITH BELZONA

ID: 1478

Industry: Marine
Application: SOS-Ships and Offshore Structures

Customer Location: Dockyard, Bulgaria
Application Date: June, 2010

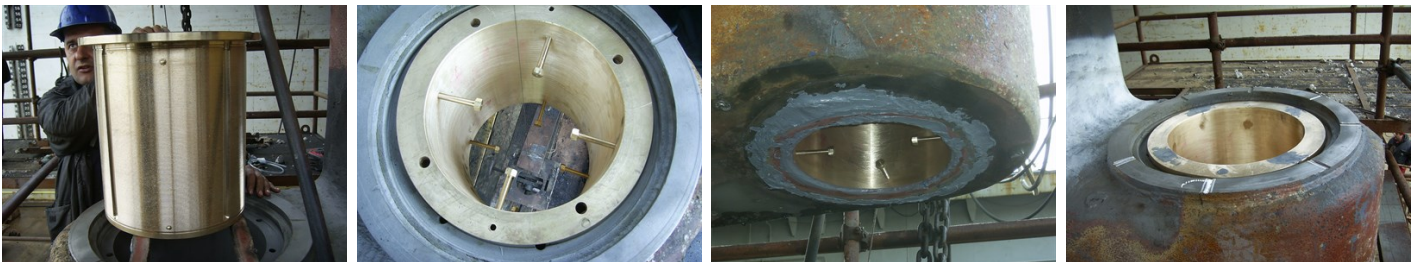
Photograph Descriptions

Corrosion damage and severe wear led to destruction of the old bearing and irregular form of the housing leading to increased annular space between the new manufactured bearing and the housing.

- * Bronze bearing machined and ready to be inserted in to the housing ,
- * Centralizing of the bearing in progress ,
- * Bae of bearing sealed with Belzona® 1221 ,
- * Finished application after injection of Belzona® 1321 ,

Installation of new bronze bearing in oversized bearing housing.

Application was carried out in accordance with Belzona Know-How System Leaflet SOS-9. The injection was through flexible hose placed into the four channels made in the back of the bearing.
