# REFORMING OF TRANSOM FLANGE WITH BELZONA

ID: 148

Industry: *Marine*  
Application: *GSS-Gaskets, Seals and Shims*  
Substrate: *Aluminum*  
Products: *\* Belzona® 1321 (Ceramic S-Metal) ,*

Customer Location: *UK ferry operator*  
Application Date: *June 1994*

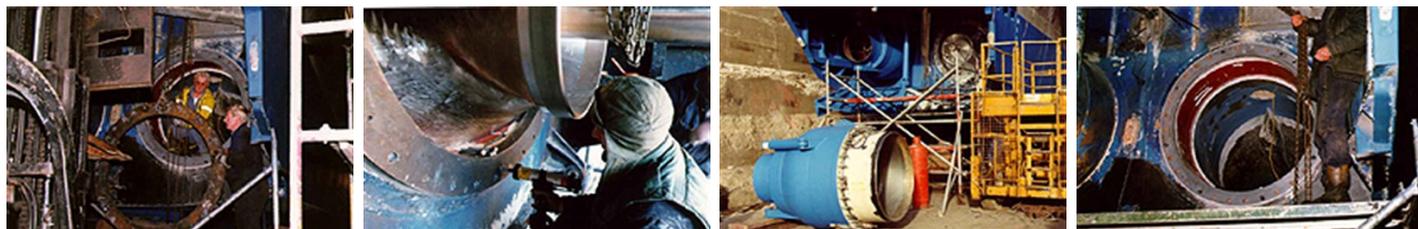
*The Transom was distorted by welding following repairs. Jet bowl no longer mated accurately with transom flange.*

- \* The forming ring being positioned ,
- \* Injection of Belzona® 1321 underway ,
- \* The perfectly formed flange face awaiting removal of corks ,
- \* The jet bowl waiting to be installed ,

Application was carried out in accordance with Belzona Know-How system GSS-9.

No simple alternative existed. Belzona application completely solved problem with minimum delay allowing ferry to resume regular service.
