BELZONA RESEATS NEW RUDDER BEARING

ID: 1480

Ships rudder pintle bearing

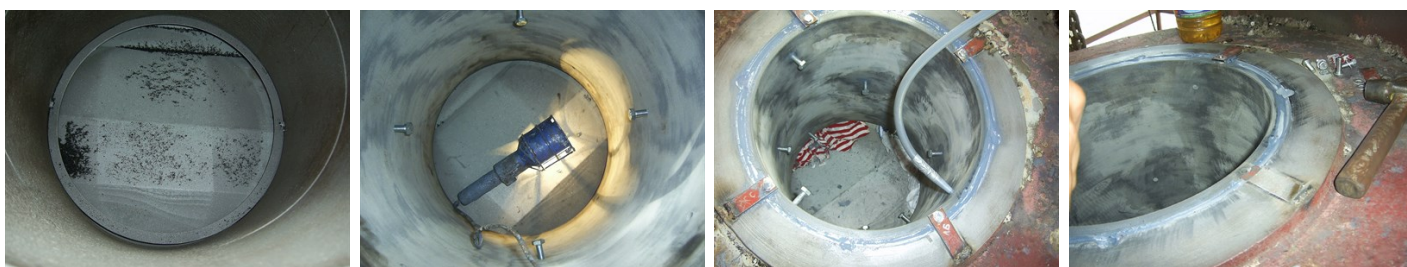
Photograph Descriptions

Severe corrosion and impact wear led to destruction of the old bronze bearing and ovality of its housing. As a result a new Orkot bush bearing was manufactured and had to be reseated in the irregular bearing housing.

- * Bearing housing after blasting ,
- * Orkot bearing inserted and fixed ,
- * Injection procedure in progress ,
- * Completed application ,

Application was carried out in accordance with Belzona Know-How System Leaflet SOS-9. The injection of Belzona® 1321 was done through injection ports drilled in the bearing wall.

Bonding the bush in place with Belzona is a proven application and is time and cost saving procedure in comparison with traditional repair which would have involved welding and boring.
