# BELZONA® REBUILT CUTWATER EDGE OF COOLING PUMP

ID: 1481

Customer Location: Nuclear Power Plant, Bulgaria  
Application Date: May, 2010

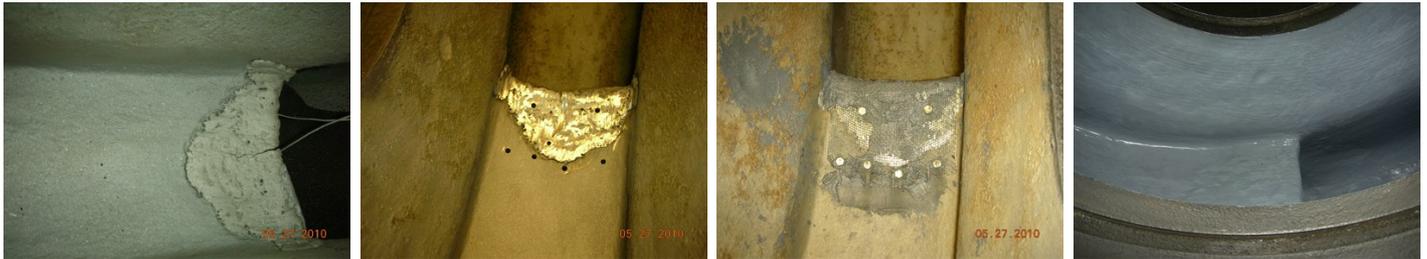
Erosion and corrosion caused wear of cutwater edge and as a result reduced pump efficiency occurred

- \* 1. Cutwater after grid blasting ,
- \* 2. Preparation of cutwater framework for screwing steel mesh ,
- \* 3. Cutwater profile restoration with Belzona 1311 in progress ,
- \* 4. Completed application with two coats Belzona 1321 ,

Application procedures were carried out in accordance with Belzona Know-How System Leaflets CEP-1 and CEP-3.

Previous attempts were made by welding of cutwater edge but without success and additionally stress cracks were appeared. Belzona cold applied approach for pump cutwater rebuild saved both time and money over traditional repairs by welding and machining without secondary problems.
