BELZONA® REBUILT CUTWATER EDGE OF COOLING PUMP

ID: 1481

Customer Location: Nuclear Power Plant, Bulgaria
Application Date: May, 2010

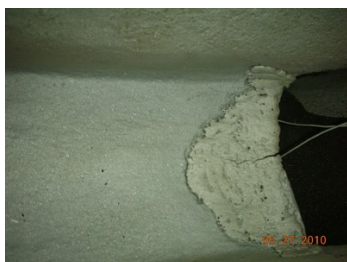
Erosion and corrosion caused wear of cutwater edge and as a result reduced pump efficiency occurred

- * 1. Cutwater after grid blasting ,
- * 2. Preparation of cutwater framework for screwing steel mesh ,
- * 3. Cutwater profile restoration with Belzona 1311 in progress ,
- * 4. Completed application with two coats Belzona 1321 ,

Previous attempts were made by welding of cutwater edge but without success and additionally stress cracks were appeared. Belzona cold applied approach for pump cutwater rebuild saved both time and money over traditional repairs by welding and machining without secondary problems.
