BELZONA SEALS PCB LEAK

ID: 1485

Industry: Chemical & Petrochemical
Application: VPF-Valves, Pipes and Fittings
Substrate: Porcelain and Copper
Products: * Belzona® 1161 (Super UW metal) ,

Customer Location: Chemical factory, Japan
Application Date: September, 2009

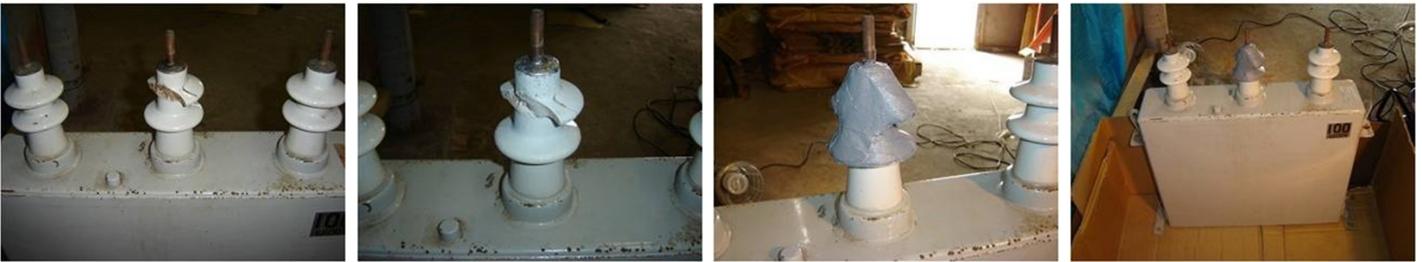
Photograph Descriptions

Leak caused by insulator damage. PCBs are extreme environmental pollutants now widely banned. Disposal can only be through specialist waste handlers. this leak was preventing safe disposal of the transformer.

- * The broken and leaking insulator ,
- * Surface preparation completed ,
- * Belzona® 1161 applied ,
- * Application completed ,

Application carried out in accordance with modified Belzona Know-How System Leaflet VPF-11a. Belzona® 1161 was applied at 3-4 mm thickness onto the broken insulator. Cure was accelerated by using heat lamps.

The customer wanted to dispose of the condenser but this request was refused by a waste disposal firm as the equipment would cause environmental contamination by PCB. The Belzona repair was completed quickly allowing disposal to safely continue without risk of polluting the environment.
