BELZONA SEALS SF6 LEAKS ON CIRCUIT BREAKER

Customer Location: Electrical distribution substation,
Australia

Bushing on 330kV circuit breaker.

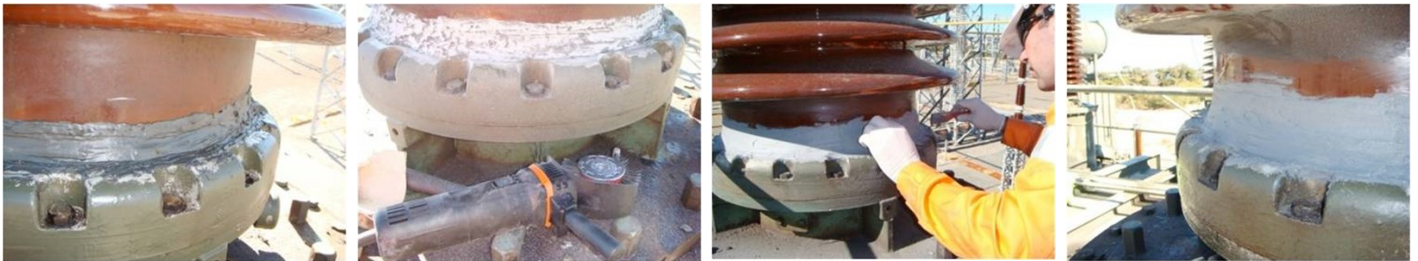
Photograph Descriptions

SF6 gas leaks through porcelain bushing seal

- * Original unsuccessful repair (still leaking) ,
- * Prepared area using the MBX Bristle blaster ,
- * Applying the Belzona® 1161 ,
- * Close up of the completed repair ,

Application was carried out in accordance with Belzona Know-How System leaflet VPF-11a. An MBX Bristle Blaster was used to prepare the surface before application of Belzona® 1161 to seal the leak area.

Application was carried out in an impressively simple and quick manner and created a totally successful gas tight seal where previous repair attempts had failed.
