# BELZONA SEALS SF6 LEAKS ON GAS CHARGED CIRCUIT BREAKER

ID: 1488

Customer Location: *Power Company, UK*  
Application Date: *2007*

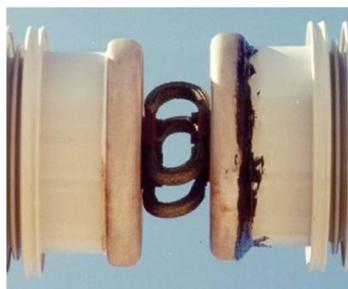
*SF6 gas leaking through porcelain bushing seals*

- \* General view of the repair area (Top and Bottom) ,
- \* Top bushing sealed ,
- \* bottom bushing sealed ,

Application was carried out in accordance with a modified Belzona Know-How System Leaflet ENC-10. Following surface preparation to profile the metal and remove the glaze from the porcelain Belzona® 2311 was used to create an elastomeric seal.
