TRANSFORMER FLANGE SEALED WITH BELZONA

ID: 1489

Customer Location: National Grid, UK
Application Date: May 2008

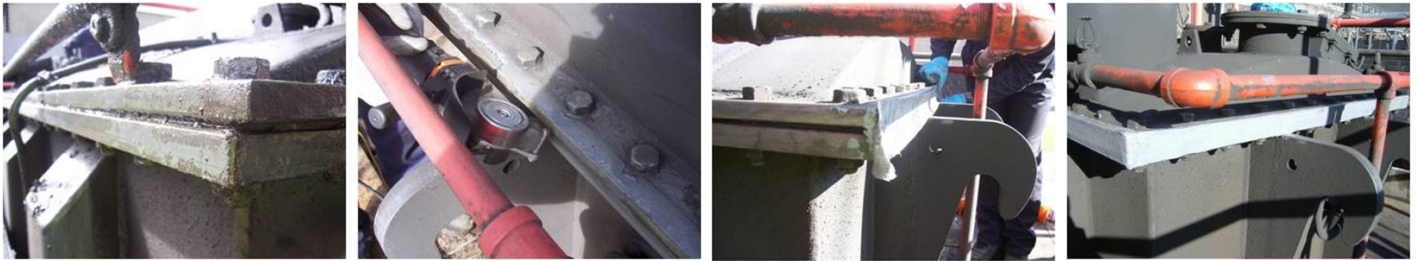
Photograph Descriptions

Oil leaks at the bolted flange joints connections

- * Leak area ,
- * MBX Bristle Blaster used for surface preparation ,
- * Belzona® 9341 and Belzona® 1161 applied to the flange joint ,
- * Application completed ,

Application was carried out in accordance with Belzona Know-How System Leaflet VPF-11a. MBX Bristle Blaster was used to prepare the surface. Belzona® 9341 (Reinforcement Tape) and Belzona® 1161 then used to seal the flange joint.

The application was very simple and effective. Work carried out without draining down the oil. Surface tolerant properties of Belzona® 1161 allows effective repair to be completed in oil contaminated areas.
