BELZONA REPAIRS SEDIMENT COLLECTOR DRAIN PIPE

ID: 1494

Customer Location: Power company, Japan
Application Date: December, 2009

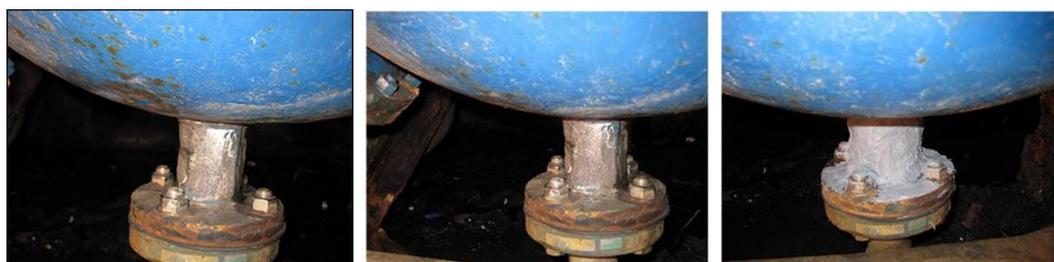
Photograph Descriptions

Industrial water was leaking from the corroded drain pipe.

- * Surface preparation completed ,
- * Leak stemmed with Belzona® 1291 ,
- * Belzona® 1161 and Reinforcement Tape applied to complete repair ,

Application was carried out in accordance with Belzona Know-How System Leaflet VPF-11a. Belzona® 1291 was used to stem the live leak. Once no leaking was ensured, Belzona® 1161 plus Belzona® 9341 (Reinforcement Tape) was immediately used to overcoat the area to create a permanent repair.
