# BELZONA REPAIRS SEDIMENT COLLECTOR DRAIN PIPE

**Industry:** Power  
**Application:** VPF-Valves, Pipes and Fittings  
**Substrate:** Carbon Steel  
**Products:** \* Belzona® 1291 (ES Metal) ,  
\* Belzona® 1161 (Super UW Metal) ,

**Customer Location:** Power company, Japan  
**Application Date:** December, 2009

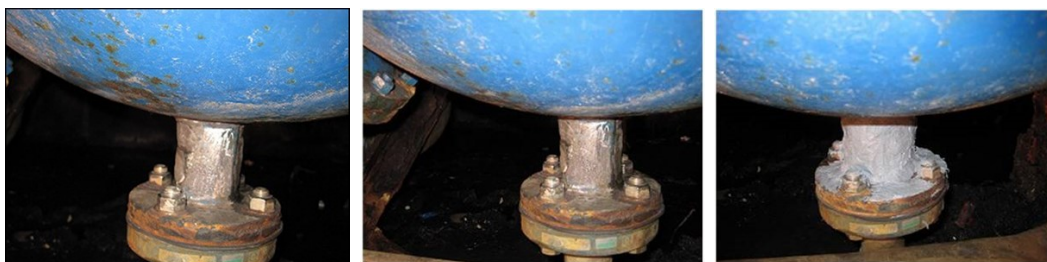
Industrial water was leaking from the corroded drain pipe.

- \* Surface preparation completed ,
- \* Leak stemmed with Belzona® 1291 ,
- \* Belzona® 1161 and Reinforcement Tape applied to complete repair ,

Application was carried out in accordance with Belzona Know-How System Leaflet VPF-11a. Belzona® 1291 was used to stem the live leak. Once no leaking was ensured, Belzona® 1161 plus Belzona® 9341 (Reinforcement Tape) was immediately used to overcoat the area to create a permanent repair.
