# LONG LASTING BELZONA ROOF PROTECTION

ID: 1496

**Industry:** Buildings & Structures  
**Application:** RPA-Roof Problem Areas  
**Substrate:** Corrugated Steel Sheet – Plastic Coated.  
**Products:** \* Belzona® 3111 (Flexible Membrane) ,

**Customer Location:** Software Distributor, UK  
**Application Date:** 1990 & June 2005

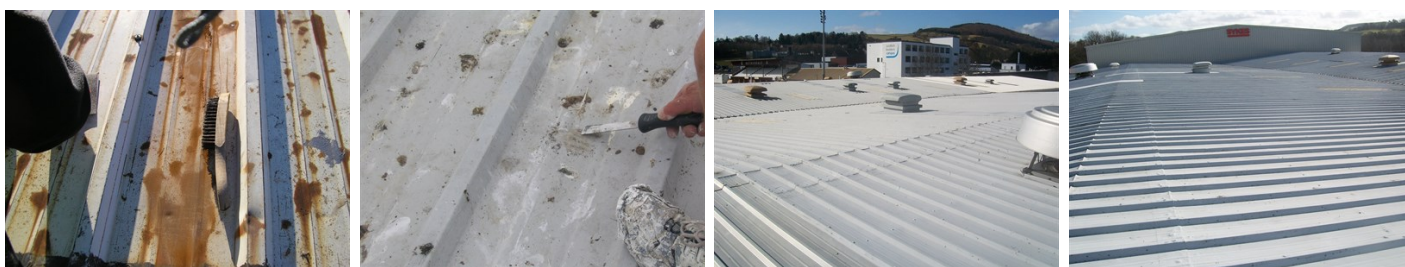
## Photograph Descriptions

The original roof had been protected with Belzona® 3111 but new extension was suffering from leaks due to attack from bird litter and excrement which was chemically attacking the plastic coated steel sections. It is possible to see the corrosion on the extension, but not on the area that was originally coated with Belzona® 3111. Original application refurbished to provide further 15 years service life.

- \* Original condition in 1990 ,
- \* Bird damage ,
- \* Application revisited in 2010 ,
- \* Application re-visited in 2010 ,

Steel corrugated pitched roof with large channel gutters running the length of the roof. The roof had several pipe penetrations, ventilation ducts and rooflight. The original roof was protected in 1990 by the local Authorized Contractor.

Application was carried out in accordance with Belzona Know-How System Leaflets RPA-1 and RPA-6.

5 year inspection in 2010 shows both applications in excellent condition and client reported zero leaks after the harshest winters in 40 years.
