# BELZONA REFURBISHES RAW WATER STRAINER

Customer Location: Power Plant, Missouri  
Application Date: Summer, 2010

Housing of raw water strainer.

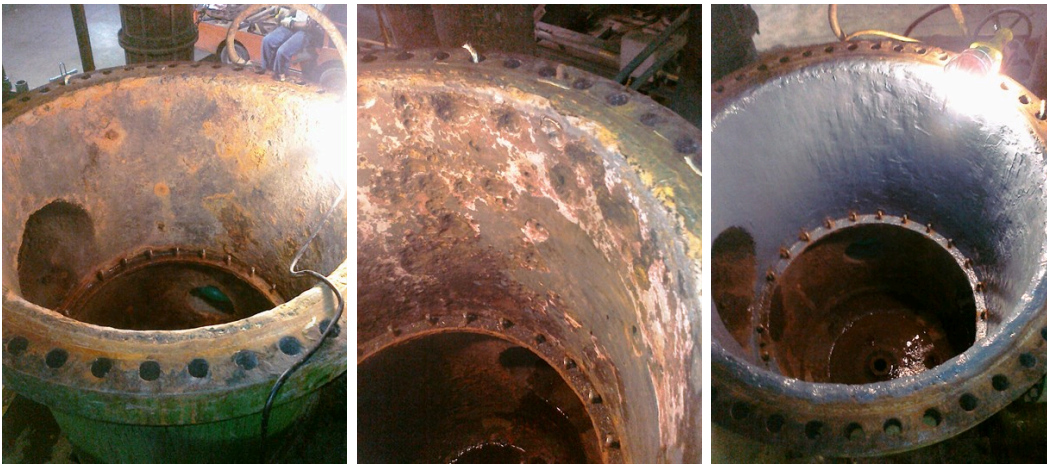
The existing coating had completely failed allowing severe pitting within the housing to occur. The customer was concerned not to allow further loss of wall thickness.

- \* The strainer housing ,
- \* Deep corrosion pitting clearly evident ,
- \* Completed application ,
- \* ,

The application was carried out in accordance with Belzona Know-How System Leaflets VPF-1 & 2. The substrate was first prepared using needle guns to remove scale and remaining coating. This exposed more pitting that the customer could not previously see. The substrate was then grit blasted before Belzona® 1311 was used to fill in pitting and smooth out the entire surface. Finally two coats of Belzona® 1321 were applied.
