BELZONA STOPS LEAK DRAIN PIPE AND HOT WELL PUMP

Leaking drain pipe and hot well pump at Water Treatment Plant

Drain pipe and hot well pump of a condenser

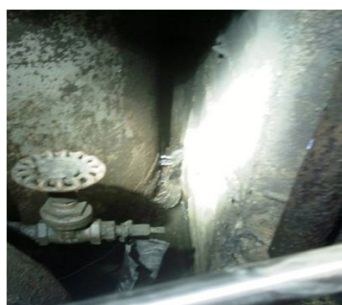
- * 1. Overview of the large sized hole on drain pipe ,
- * 2. To seal with Belzona 1161 ,
- * 3. Live leaks of hot well pump ,
- * 4. Stop leak with Belzona 1291 and Belzona 1161 ,

The application was carried out in accordance with a modified of Belzona Know-How System Leaflet HEX-9 and CEP-6 . First, Belzona 1291 was used to stop the leak, then Belzona 1161 along with Belzona 9341 covered the area.
