# BELZONA SEALS GASOLINE STORAGE TANK

Industry: *Chemical & Petrochemical*  
Application: *TCC-Tanks and Chemical Containment Areas*  
Substrate: *Steel*  
Products: *\* Belzona® 1161 (Super UW Metal) ,*

Customer Location: *Petrochemical plant, Ontario, Canada*  
Application Date: *Summer 2008*

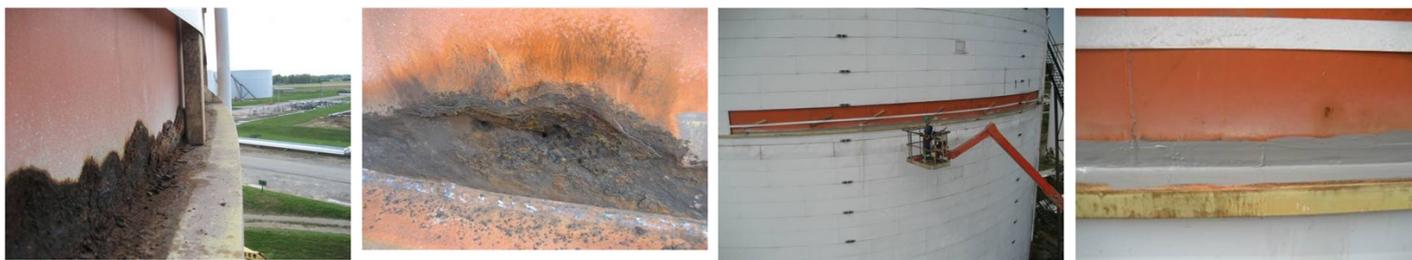
*Water was collecting on this large reinforcement seam causing extensive corrosion.*

- \* Large corrosion area ,
- \* Severity of corrosion clearly evident ,
- \* Use of crane lift to access repair area ,
- \* Completed Application ,

Application was carried out in accordance with Belzona Know-How System Leaflet TCC-1. The application was completed from the support equipment (crane).

Belzona® 1161 was used due to the difficulty in accessing and removing all condensation in the repair area. The application is in excellent condition until today without any problems.
