# BELZONA TRUNNION BEARING HOUSING REPAIR SAVES MONEY

ID: 1503

Customer Location: Steel mill, Missouri  
Application Date: Summer 2010

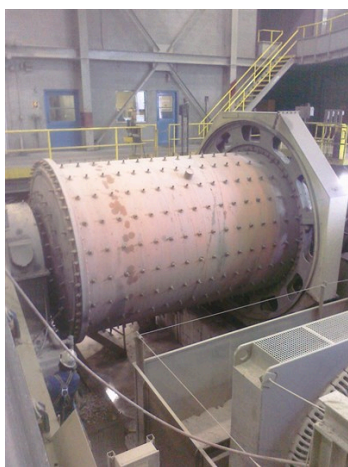
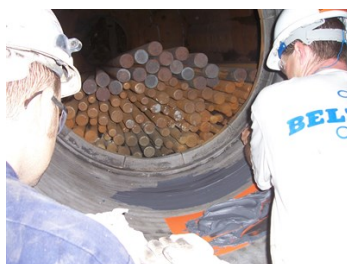
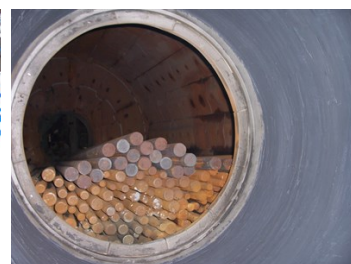
Bearing housing had allowed particulates to pass into housing and caused significant wear. Rod Mill downtime costs 20k per hour.

\* Overview of Rod Mill Close up of worn housing Applying the Belzona® 1311 Final repair ,

Rod Mill trunnion bearing housing had significant wear and insufficient downtime for traditional weld/machining repair.

Application was carried out in accordance with Belzona Know-How System Leaflet MPT-2. Housing was heated with torch to sweat out oils. The substrate was then blasted to a 2-3 mil profile. Application of the Belzona® 1311 followed to rebuild housing back to OEM specification.
