BELZONA SEALS OIL LEAK AND PROTECTS THE ENVIRONMENT

ID: 1512

Customer Location: Electrical Substation, UK
Application Date: 2007

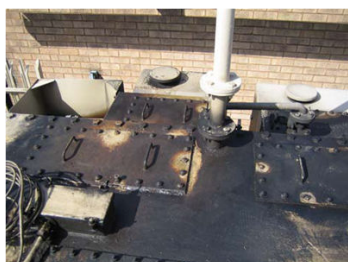
Transformer oil leaking from the top of the transformer onto the ground was heading towards a drain in the road, posing a serious environmental problem.

- * Leaking transformer ,
- * Surface preparation using MBX Bristle Blaster ,
- * Surface preparation completed and live leak sealed with Belzona® 1291 ,
- * Repair completed with application of Belzona® 1161 ,

Application was carried out in accordance with Belzona Know-How System Leaflet VPF-11a. Surface was cleaned the prepared with MBX Bristle Blaster. Belzona® 1291 was used to seal the visible leaks before the application of Belzona® 1161 and Belzona® 9311 (Reinforcing Sheet).
