BELZONA PROTECTS WATER TREATMENT PLANT FILTER

ID: 1515

Customer Location: Water treatment plant, Girona, Spain
Application Date: May 2008

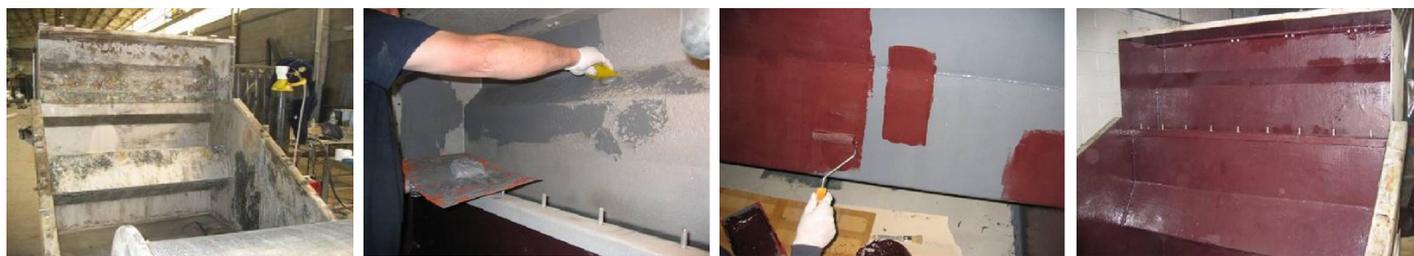
Photograph Descriptions

Severe corrosion of the stainless steel substrate due to the presence of Hydrogen Sulphide and Sulphuric acid. These are created by bacterial action in the organic matter.

* ,
<div style="font-family: Verdana, Arial, Helvetica, sans-serif; font-size: 10px; background-color: #ffffff;">
* Initial state of the sieve ,
* Rebuilding with Belzona® 1121 ,
* Application of the second coating of Belzona® 4311 ,
* Finished unit ,
</div>
* ,

Application was carried out in accordance with Belzona Know-How System Leaflet TCC-5. After grit blasting, deeply corroded areas were rebuilt using Belzona® 1121 followed by coating with two layers (grey and red) of Belzona® 4311.

The filter was rapidly repaired and put back into service. The Belzona® 4311 provides excellent corrosion protection to all concentrations of Sulphuric acid ensuring long term protection of the equipment.
