# SEALING TRANSFORMER OIL VALVES WITH BELZONA

**Industry:** Power  
**Application:** VPF-Valves, Pipes and Fittings  
**Substrate:** Carbon steel and plastic.  
**Products:** \* Belzona® 1161 (Super UW-Metal) ,

**Customer Location:** Electricity distribution, Vitoria, Spain  
**Application Date:** December 2009.

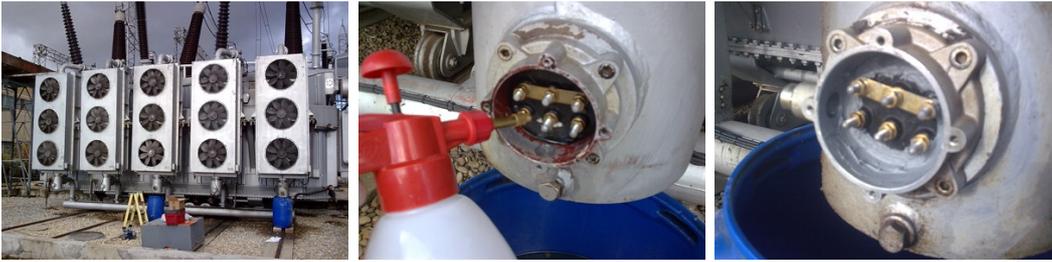
Valves were leaking oil due to a defective flange seal.

- \* General view of the location for the unit ,
- \* Cleaning the application area. ,
- \* Final result after application of Belzona® 1161 ,

The application was carried out according to the Belzona Know-How System Leaflet VPF-12,

Using Belzona surface tolerant material, the leak was stopped reducing maintenance costs and extending the service life of the equipment. Impact on the environment was also reduced.
