SEALING TRANSFORMER OIL VALVES WITH BELZONA

ID: 1518

Customer Location: Electricity distribution, Vitoria, Spain
Application Date: December 2009.

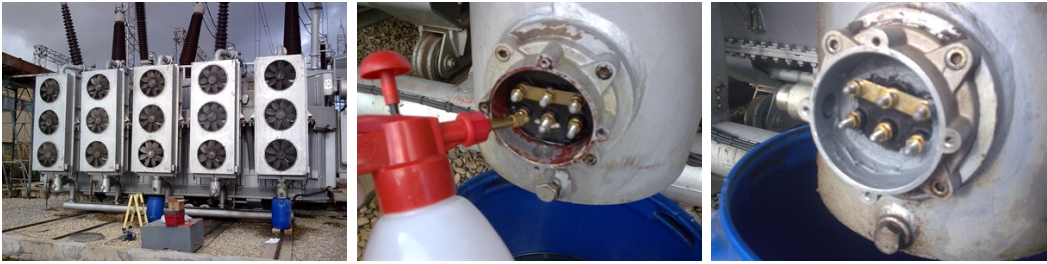
Valves were leaking oil due to a defective flange seal.

- * General view of the location for the unit ,
- * Cleaning the application area. ,
- * Final result after application of Belzona® 1161 ,

Oil valves feeding a transformer at substation.

The application was carried out according to the Belzona Know-How System Leaflet VPF-12,

Using Belzona surface tolerant material, the leak was stopped reducing maintenance costs and extending the service life of the equipment. Impact on the environment was also reduced.
