# REPAIR AND PROTECTION OF HOSPITAL LAUNDRY FLOOR WITH BELZONA

ID: 1523

Customer Location: Hospital, Scotland

Application: FPA-Floor Problem Areas

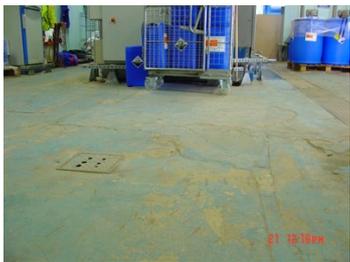
The laundry floor of this hospital was not level and water was gathering in the middle of the floor. They needed the floor to be re-levelled so that water ran to the drains. The floor also had to be safe from accidents.

\* Uneven, damaged laundry floor Application of Belzona® 4131 Application of Belzona® 4131 Completed application ,
