# REPAIR AND PROTECTION OF HOSPITAL LAUNDRY FLOOR WITH BELZONA

ID: 1523

Customer Location: Hospital, Scotland  
Application Date: Oct/ Nov 2009

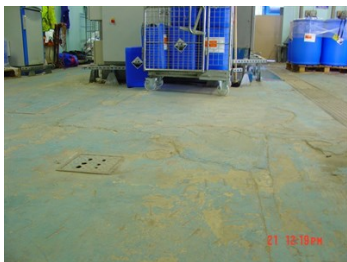
The laundry floor of this hospital was not level and water was gathering in the middle of the floor. They needed the floor to be re-levelled so that water ran to the drains. The floor also had to be safe from accidents.

\* Uneven, damaged laundry floor Application of Belzona® 4131 Application of Belzona® 4131 Completed application ,
