REPAIR AND PROTECTION OF HOSPITAL LAUNDRY FLOOR WITH BELZONA

Customer Location: Hospital, Scotland

Application: FPA-Floor Problem Areas

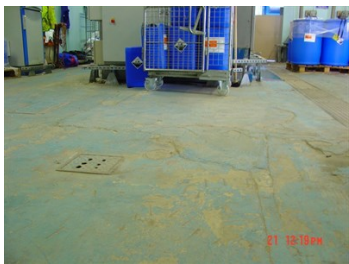
The laundry floor of this hospital was not level and water was gathering in the middle of the floor. They needed the floor to be re-levelled so that water ran to the drains. The floor also had to be safe from accidents.

* Uneven, damaged laundry floor Application of Belzona® 4131 Application of Belzona® 4131 Completed application ,

Application was carried out in accordance with Belzona Know-How System Leaflet FPA-1. Existing floor was cut out to create a fall and then screeded over with Belzona® 4131. This was then overcoated with Belzona® 5231.
