# BELZONA REPAIRS TO SPALLED CONCRETE

ID: 154

**Customer Location:** *Art college in U.K.*  
**Application Date:** *1996*

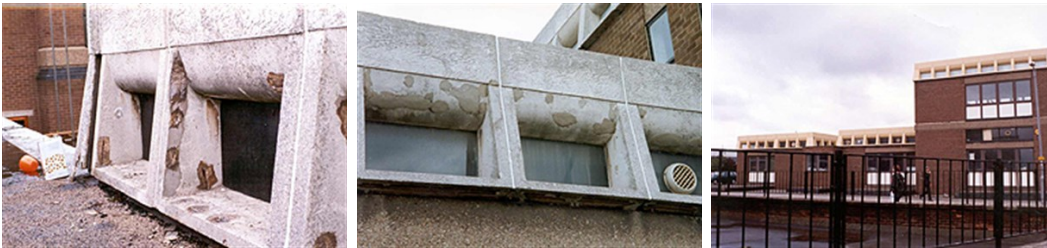
*Carbonation of the concrete allowing corrosion of the steel reinforcing leading in turn to serious spalling of the concrete.*

- \* Some of the extensive spalling prepared and conditioned ,
- \* Belzona® 4141 applied to rebuild the spalled concrete ,
- \* Completed application ,

Permanent repairs were carried out with minimum access time. Belzona coating will prevent further carbonation on surrounding areas.
