BELZONA REPAIRS TO SPALLED CONCRETE

ID: 154

Customer Location: *Art college in U.K.*
Application Date: *1996*

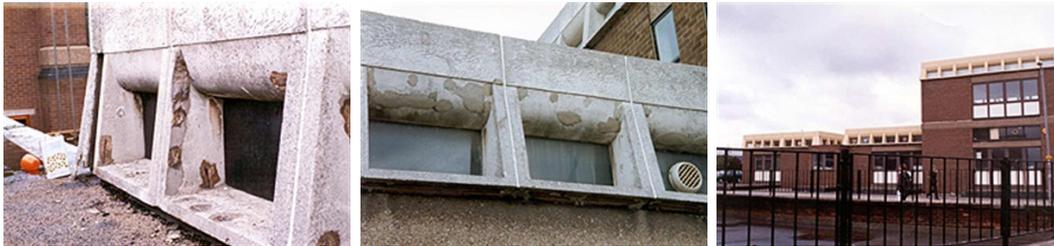
Photograph Descriptions

Carbonation of the concrete allowing corrosion of the steel reinforcing leading in turn to serious spalling of the concrete.

- * Some of the extensive spalling prepared and conditioned ,
- * Belzona® 4141 applied to rebuild the spalled concrete ,
- * Completed application ,

Application was carried out in accordance with Belzona System Leaflet RPA-2.

Permanent repairs were carried out with minimum access time. Belzona coating will prevent further carbonation on surrounding areas.
