# BELZONA BELT SWAT TEAM

ID: 156

Application: *SHM-Solids Handling Machinery*

Customer Location: *Paper Mill in Jacksonville, Florida*

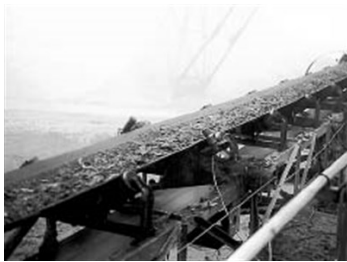
*A small hole under belt tension is expected to get larger and debris was leaking through the belt.*

- \* Belt delivers bark to powerhouse, 24 hours a day, 7 days a week ,
- \* Surface preparation completed using Belzona roughening brush, and Belzona® 2911 (Q.D. Conditioner) is applied ,
- \* Hole successfully patched by the happy crew (Belt Swat Team)! ,
