BELZONA PROVEN PROTECTION FOR SEDIMENTATION TANK

ID: 1574

Customer Location: *Pharmaceutical producer, Slovakia*
Application Date: *1998 to September, 2010*

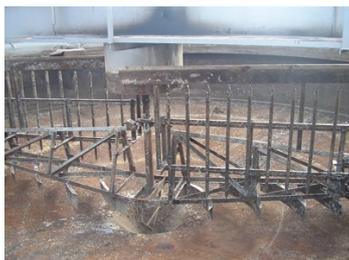
The tanks suffer from severe corrosion.

- * Tank showing severe corrosion ,
- * Grit-blasting the tank ,
- * Setting up the spray equipment ,
- * Tank after the application ,

Application was carried out in accordance with Belzona Know-How System Leaflet TCC-5. The Belzona was applied using Airless spray equipment.
