BELZONA FLOOR REPAIRS IN CIDER FACTORY

ID: 1575

Industry: Buildings & Structures
Application: FPA-Floor Problem Areas
Substrate: Concrete
Products: * Belzona® 4131 (Magma Screed) ,

Customer Location: Cider Manufacturer, UK
Application Date: 2009

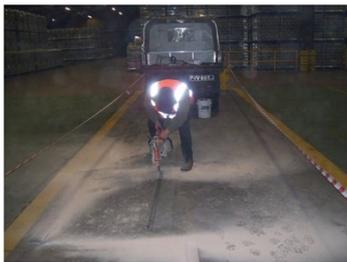
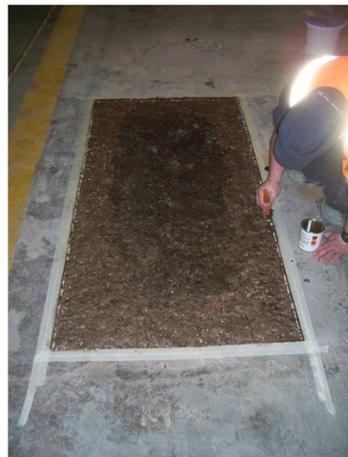
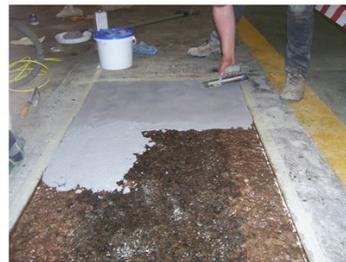
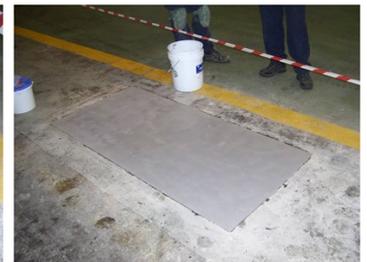
Photograph Descriptions

Lorry trailers park here and the stabilisers when lowered damage the floor area after 6-8 months.

- * Preparation of damaged area ,
- * Application of Conditioner ,
- * Applying Belzona® 4131 ,
- * Completed Application ,

Application was carried out in accordance with Belzona Know-How System Leaflet FPA-1.

The repairing and protection of the floor in these localised areas with Belzona® 4131 resists both impact and abrasion thus extending the life of the floor area leading to reduced maintenance. The customer was very pleased with the results and this job
