# BELZONA FLOOR REPAIRS IN CIDER FACTORY

ID: 1575

Industry: Buildings & Structures  
Application: FPA-Floor Problem Areas  
Substrate: Concrete  
Products: \* Belzona® 4131 (Magma Screed) ,

Customer Location: Cider Manufacturer, UK  
Application Date: 2009

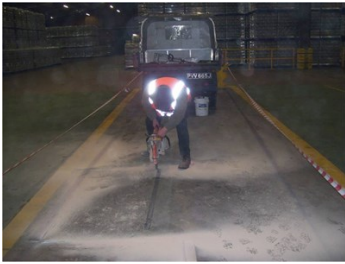
Lorry trailers park here and the stabilisers when lowered damage the floor area after 6-8 months.

- \* Preparation of damaged area ,
- \* Application of Conditioner ,
- \* Applying Belzona® 4131 ,
- \* Completed Application ,

Application was carried out in accordance with Belzona Know-How System Leaflet FPA-1.
