PROVEN BELZONA SUCCESS ON CONDENSATE TANK PROTECTION

Industry: Buildings & Structures
Application: TCC-Tanks and Chemical Containment Areas
Substrate: Concrete
Products: * Belzona® 1391 (Ceramic HT) ,
* Belzona® 1511 (Super HT Metal) ,

Customer Location: University, Southeast Wyoming
Application Date: August 2008 & 2010

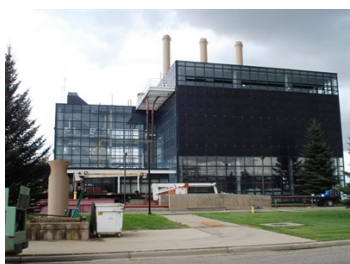
Original competitor lining failed catastrophically.

- * Universities hot water plant ,
- * Original Belzona coating application ,
- * Touch-ups on tank walls ,
- * Touch-ups On tank floor ,

Original Belzona application was carried out in 2008. In August 2010 the application was inspected and only minor touch ups were required where underlying concrete had cracked.
