PROVEN BELZONA SUCCESS ON CONDENSATE TANK PROTECTION

Industry: Buildings & Structures
Application: TCC-Tanks and Chemical Containment Areas
Substrate: Concrete
Products: * Belzona® 1391 (Ceramic HT),
* Belzona® 1511 (Super HT Metal),

Customer Location: University, Southeast Wyoming
Application Date: August 2008 & 2010

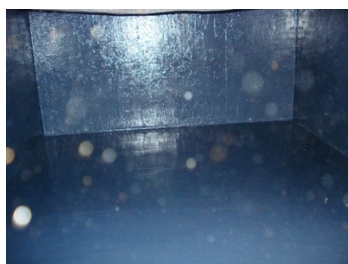
- * Universities hot water plant ,
- * Original Belzona coating application ,
- * Touch-ups on tank walls ,
- * Touch-ups On tank floor ,

Original Belzona application was carried out in 2008. In August 2010 the application was inspected and only minor touch ups were required where underlying concrete had cracked.

Application was carried out in accordance with modified Belzona Know-How System Leaflets TCC-3.
