PROVEN BELZONA SUCCESS ON CONDENSATE TANK PROTECTION

ID: 1576

Customer Location: University, Southeast Wyoming
Application Date: August 2008 & 2010

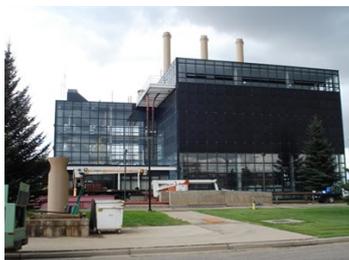
- * Universities hot water plant ,
- * Original Belzona coating application ,
- * Touch-ups on tank walls ,
- * Touch-ups On tank floor ,

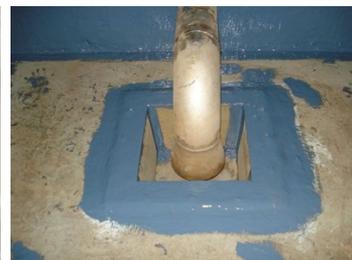
Original Belzona application was carried out in 2008. In August 2010 the application was inspected and only minor touch ups were required where underlying concrete had cracked.
