Belzona SuperWrap seals weeping storage tank

ID: 1577

Industry: Power
 Application: VPF-Valves, Pipes and Fittings
 Substrate: Mild Steel
 Products: * Belzona® Superwrap ,

Customer Location: Energy Company
 Application Date: April, 2009

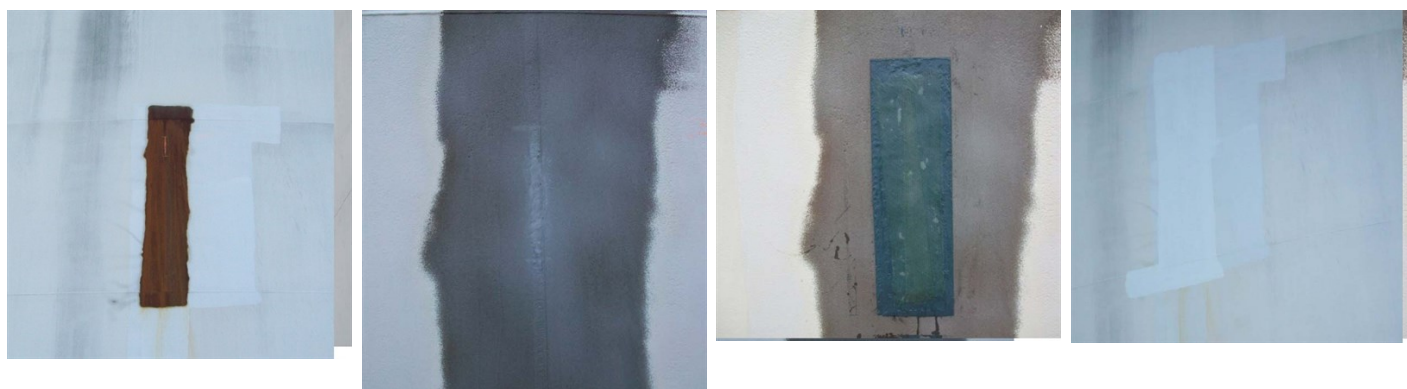
Photograph Descriptions

Vertical weld was found to be very porous and fuel oil was weeping from a 2 mm through wall defect. No corrosion or thin wall area was detected. Defect was located at 30 feet from the ground level.

- * Damaged area ,
- * Area prepared by abrasive blasting ,
- * Belzona® SuperWrap application ,
- * Belzona® SuperWrap repair inspected and painted over ,

SuperWrap composite system was applied in compliance with ISO/TS 24817 and ASME PCC-2. Belzona® Superwrap composite repair system was applied at 10 mm thickness and over a 100 x 355mm area.

The repair was completed without resort to hotwork. Belzona® Superwrap System was inspected in 2010 and found to be in perfect

condition.
