## Belzona SuperWrap seals weeping storage tank

ID: 1577

Industry: *Power*  
 Application: *VPF-Valves, Pipes and Fittings*  
 Substrate: *Mild Steel*  
 Products: *\* Belzona® Superwrap ,*

Customer Location: *Energy Company*  
 Application Date: *April, 2009*

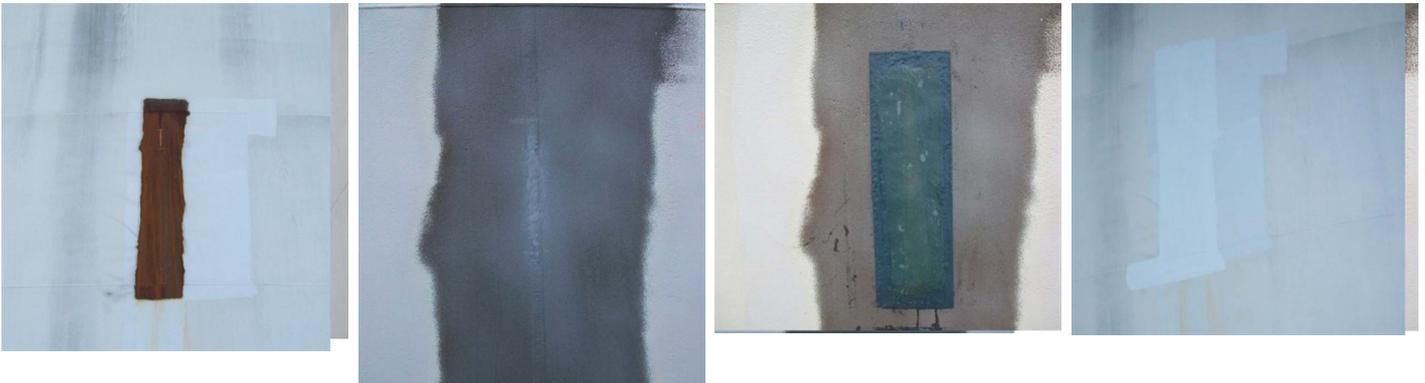
*Vertical weld was found to be very porous and fuel oil was weeping from a 2 mm through wall defect. No corrosion or thin wall area was detected. Defect was located at 30 feet from the ground level.*

- \* Damaged area ,
- \* Area prepared by abrasive blasting ,
- \* Belzona® SuperWrap application ,
- \* Belzona® SuperWrap repair inspected and painted over ,

SuperWrap composite system was applied in compliance with ISO/TS 24817 and ASME PCC-2. Belzona® Superwrap composite repair system was applied at 10 mm thickness and over a 100 x 355mm area.

The repair was completed without resort to hotwork. Belzona® Superwrap System was inspected in 2010 and found to be in perfect

condition.
