Belzona SuperWrap seals weeping storage tank

ID: 1577

Industry: *Power*
 Application: *VPF-Valves, Pipes and Fittings*
 Substrate: *Mild Steel*
 Products: ** Belzona® Superwrap ,*

Customer Location: *Energy Company*
 Application Date: *April, 2009*

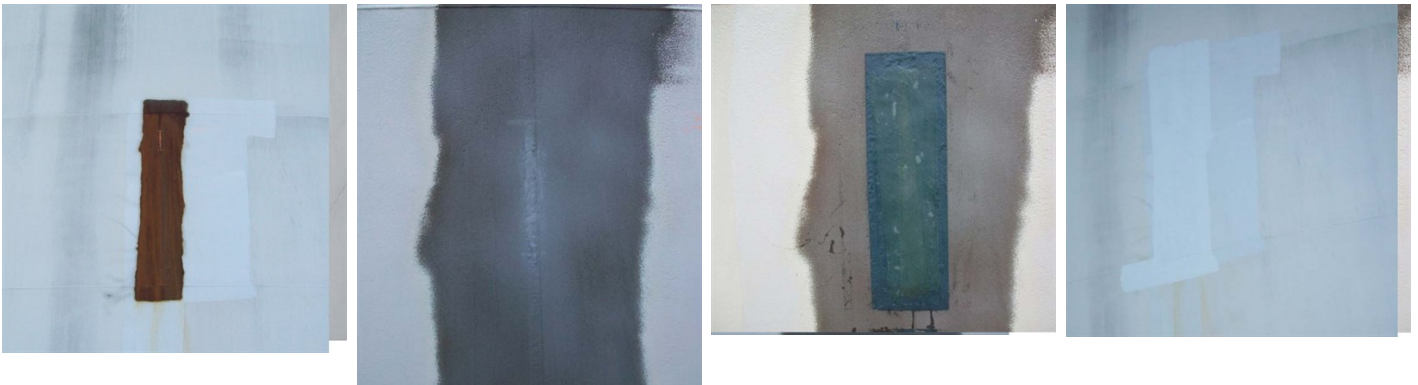
Photograph Descriptions

Vertical weld was found to be very porous and fuel oil was weeping from a 2 mm through wall defect. No corrosion or thin wall area was detected. Defect was located at 30 feet from the ground level.

- * Damaged area ,
- * Area prepared by abrasive blasting ,
- * Belzona® SuperWrap application ,
- * Belzona® SuperWrap repair inspected and painted over ,

SuperWrap composite system was applied in compliance with ISO/TS 24817 and ASME PCC-2. Belzona® Superwrap composite repair system was applied at 10 mm thickness and over a 100 x 355mm area.

The repair was completed without resort to hotwork. Belzona® Superwrap System was inspected in 2010 and found to be in perfect

condition.
