BELZONA BACKHOE SWING ARM REPAIR AT EQUIPMENT RENTAL COMPANY

ID: 158

Backhoe swing arm

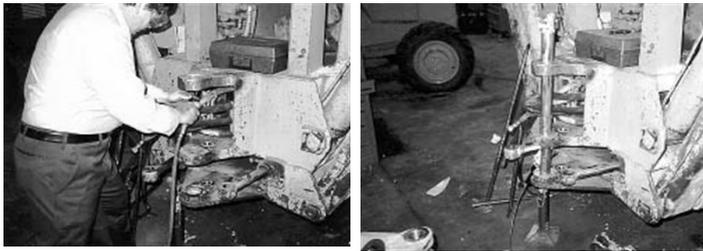
Photograph Descriptions

All three swing arm bushings had been destroyed and the metal of the bushing bores was severely worn.

- * Preparation in progress ,
- * Bushings installed ,

The application was carried out in accordance with Belzona Know-How Leaflet MPT-8.

Typically, rental units tend to get abused. The previous year, a similar repair was done for this customer on another unit damaged when the machine was being transported on the highway. The swing arm was left up too high and hit an overpass at 55 mph. Despite numerous repairs over the years, the swing arm bushing fits have never had to be redone as of January, 1994. About \$30 of Belzona® 1111 Super Metal was used by one man in 1/2 hour to do this fix. A conventional repair was quoted at \$7,500.
