EXTERNAL TANK CORROSION PROTECTION WITH BELZONA

Customer Location: Fuel distribution company, Tamaulipas, Mexico

Application: TCC-Tanks and Chemical Containment Areas

Oil storage tank

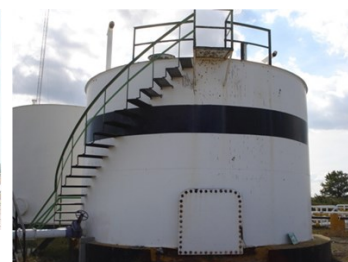
Tank walls were suffering from external corrosion

* Surface preparation Applying Belzona® 6111 Application completed Tank ten years after application ,

The application was carried out in accordance with Belzona Know-How System Leaflet TCC-5.

10 years after the application, the inspection showed the Belzona product was in perfect condition. The Belzona application saved the customer an estimated US\$ 39,500 through reduced maintenance costs.
