# BELZONA PROTECTS NEW FLASH DRUM

ID: 1581

Customer Location: Oil Company, Sierra Chata, Argentina  
 Application Date: June 2007

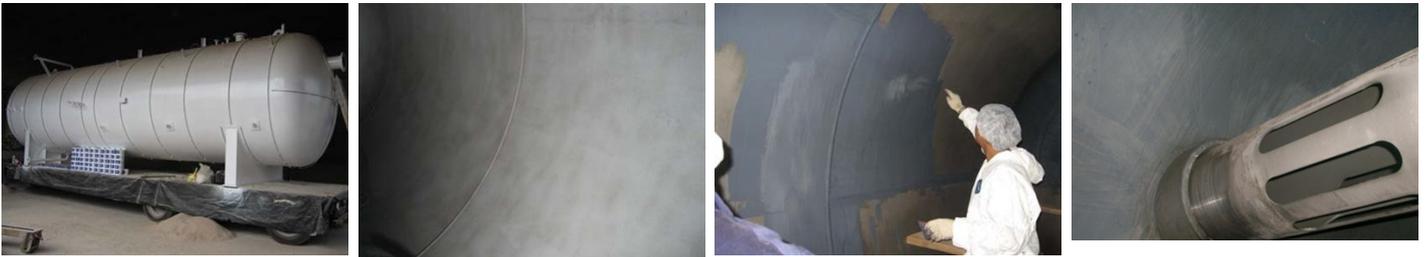
\* Flash drum prior to commencement of application Surface Preparation by abrasive blast cleaning Application of Belzona 1391 underway Photo taken during inspection at 2010 shutdown ,

Application was carried out in accordance with Belzona Know-How System TCC-5. The Belzona® 1391 was applied as a one coat system and was inspected using wet sponge for defects.

An inspection was conducted in September 2010 during shut down and May 2012, and the product was found to be in perfect condition. The use of Belzona will allow this vessel to continue in service for many more years.
