BELZONA REPAIRS UNDERWATER PIPE ON OFFSHORE PLATFORM

ID: 1582

Customer Location: Oil and Gas Platform, Brazil

Application Date: March 2008

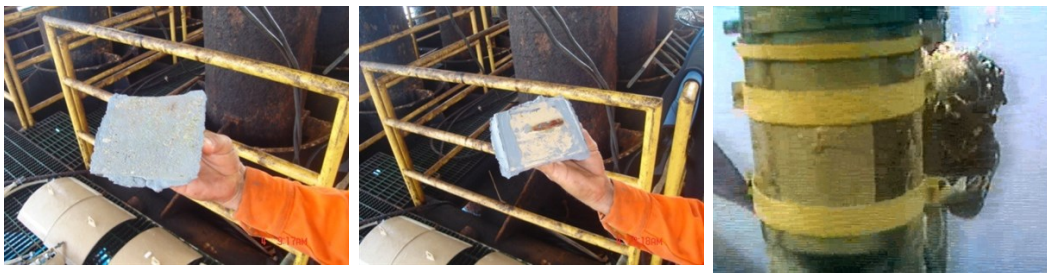
Photograph Descriptions

Sump pipe was cracked due to impact. It was required to seal the affected area under water.

- * Adhesion test being carried out with plates coated with Belzona® 5831 prior to application ,
- * Testing Belzona® 1161 on edges of plate under immersed conditions ,
- * Application being carried out by divers under water ,

Application was carried out using a modified version of Belzona Know-How System Leaflet VPF-11a. Surface was cleaned in accordance with ISO 8501-1 St2/3 using pneumatic sander. Prior to commencement of the application several plates were coated with Belzona® 5831 for future corrosion protection. Plates bonded in place by diver using Belzona® 1161. Clamps were used to hold plates in place during curing process.

Practical training was carried out with the divers prior to carrying out the actual application. Upon completion, inspection was carried out and a small leak was detected. The leak was repaired with the Belzona® 1161/5831 system. This repair is in perfect condition when last inspected in 2010.
