BELZONA GETS COMPRESSOR BACK TO SERVICE IN HOURS

CO2 compressor, a key equipment in producing Amide fertilizer.

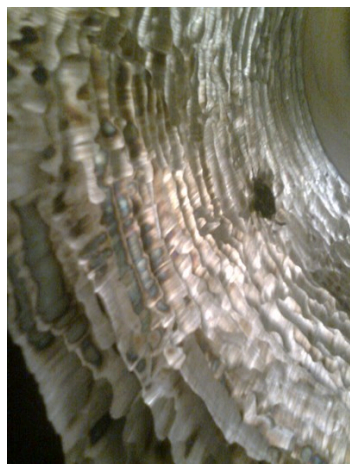
Worn compressors are unable to supply the necessary amount of CO2 into the production line.

- * Worn surface ,
- * Injecting Belzona® 1321 ,
- * Smooth finished surface after removing former ,
- * Finished compressor housing ,
