# BELZONA GETS COMPRESSOR BACK TO SERVICE IN HOURS

CO2 compressor, a key equipment in producing Amide fertilizer.

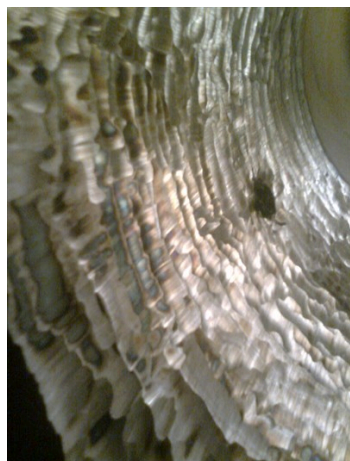
*Worn compressors are unable to supply the necessary amount of CO2 into the production line.*

- \* Worn surface ,
- \* Injecting Belzona® 1321 ,
- \* Smooth finished surface after removing former ,
- \* Finished compressor housing ,
