BELZONA GETS COMPRESSOR BACK TO SERVICE IN HOURS

Industry: *Buildings & Structures*
Application: *CEP-Centrifugal Pumps*
Substrate: *Steel*
Products: ** Belzona® 1321 (Ceramic S-Metal) ,*

Customer Location: *Fertilizer producer, Hungary*
Application Date: *2010*

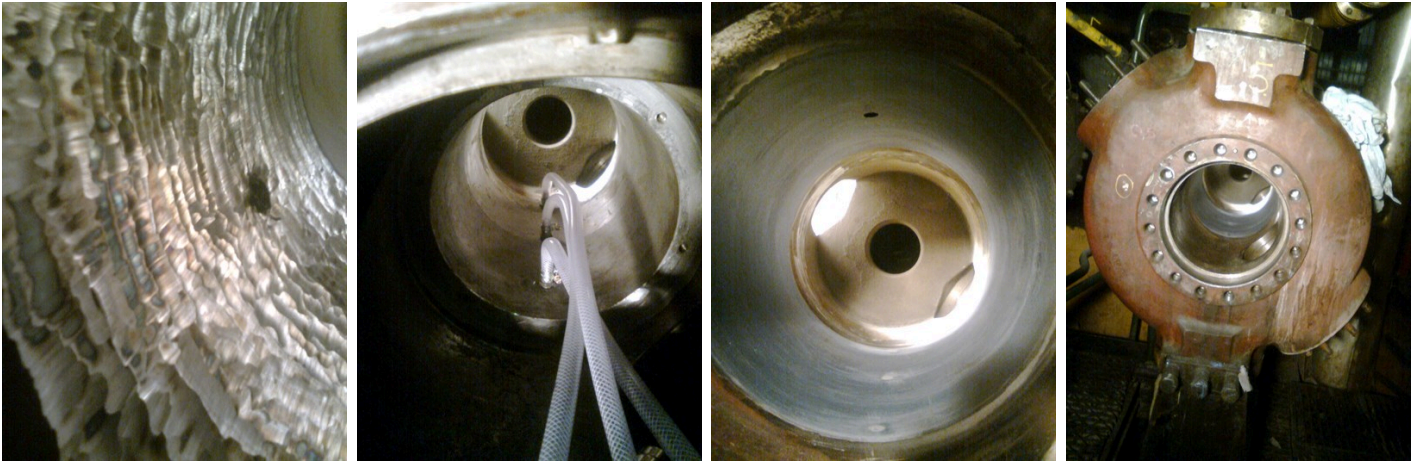
Photograph Descriptions

Worn compressors are unable to supply the necessary amount of CO2 into the production line.

- * Worn surface ,
- * Injecting Belzona® 1321 ,
- * Smooth finished surface after removing former ,
- * Finished compressor housing ,

Application is carried out in accordance with a modified version of Belzona Know-How System Leaflet PDP-2 and MPT-2. Belzona® 1321 is injected into a stainless steel form prepared to match the required bore. It is treated with Belzona® 9411 (Release Agent) to aid removal once the Belzona® 1321 has cured.

The cost of such an application is only a small fraction of a new equipment purchase. Another competitor had already failed because of its hand applied surface. Injecting Belzona® 1321 provides perfect and smooth surface within just a few hours.
