BELZONA TACKLES SEVERE CUI ON COLUMN

ID: 1586

Customer Location: Refinery, UK
Application Date: November 2005

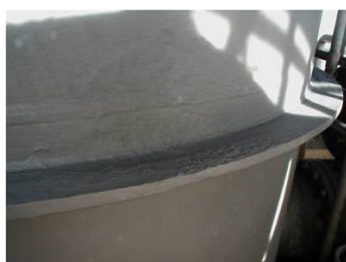
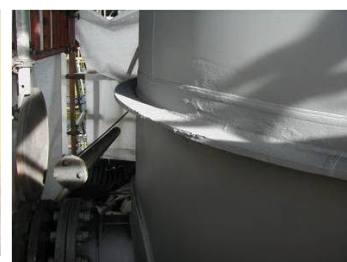
- * General view of refinery ,
- * Application area after grit-blasting ,
- * Completed application ,
- * Completed application ,

Severe Corrosion Under Insulation (CUI) on columns

Application was carried out in accordance with Belzona Know-How System Leaflet TCC-5. The Belzona® 5851 was hand applied as a two coat system to grit blasted 8m sections of the column that were then re lagged before moving on to the next section. vessel remained in service throughout the application.

Having tried numerous other products and rejecting them either for application or Health & Safety issues, Belzona was selected as the only product capable of being safely and easily applied online. An inspection in November 2007 showed no visible signs of degradation.
