BELZONA REBUILDS BAKERY FLOOR

ID: 1587

Customer Location: Bakery, Northern Ireland
Application Date: August 2009

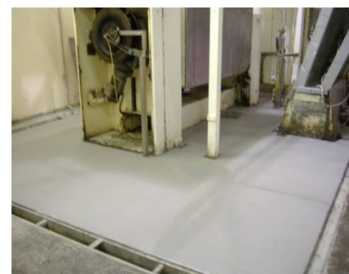
Photograph Descriptions

Oils, flour and cleaning water were going under the dough mixing machine. falls needed to be created to enhance drainage and ease of cleaning in this hygiene area.

- * Floor problem area ,
- * Floor area after cleaning and abrasion ,
- * Belzona Conditioner being applied ,
- * Floor area screeded with Belzona® 4131 ,

Application was carried out in accordance with Belzona Know-How System Leaflets FPA-1 & 6. A flexible seal using Belzona® 2221 was included to absorb the machines vibrations and to prevent foodstuffs from going under the machine.
