# BELZONA UPGRADE TO FLOOR IN CHOCOLATE FACTORY

ID: 1588

Customer Location: Chocolate manufacturer, Derbyshire, UK  
Application Date: December 2009

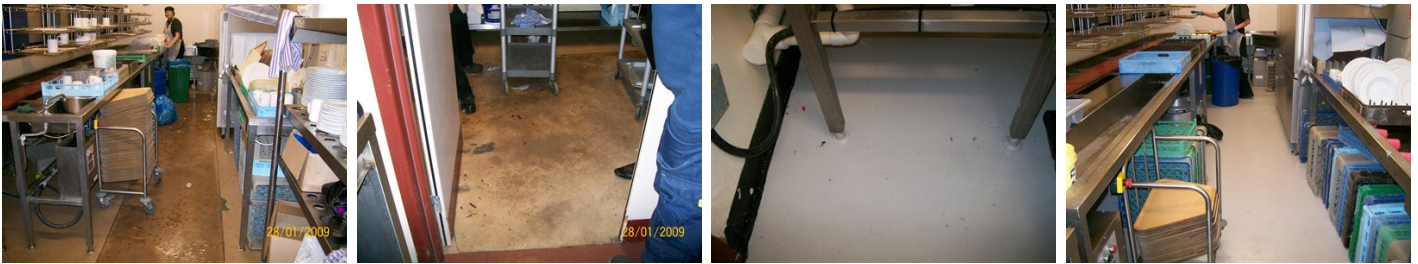
The existing coating had begun to deteriorate and sections of the main walk area had been removed exposing the concrete substrate beneath. This was not only unsightly; it also represented a health risk as staff were unable to clean the floor area adequately as food particles become trapped in the surface. The area also presented a considerable slip risk.

- \* Floor Areas to be Repaired ,
- \* Floor Areas to be Repaired ,
- \* Completed Floor Application ,
- \* Completed Floor Application ,

The remainder of the original floor coating was uplifted and the whole concrete floor area Application was carried out in accordance with Belzona Know-How System Leaflet FPA-3.

The clients requirements and expectations have been met in full and they are very pleased with the results. the floor provides a hygienic surface that cannot harbour bacteria and also provides a slip resistant surface for the staff.
